NPIC/R-568/64  
July 1964

PHOTOGRAPHIC INTERPRETATION REPORT

# KYSHTYM ATOMIC ENERGY COMPLEX, USSR

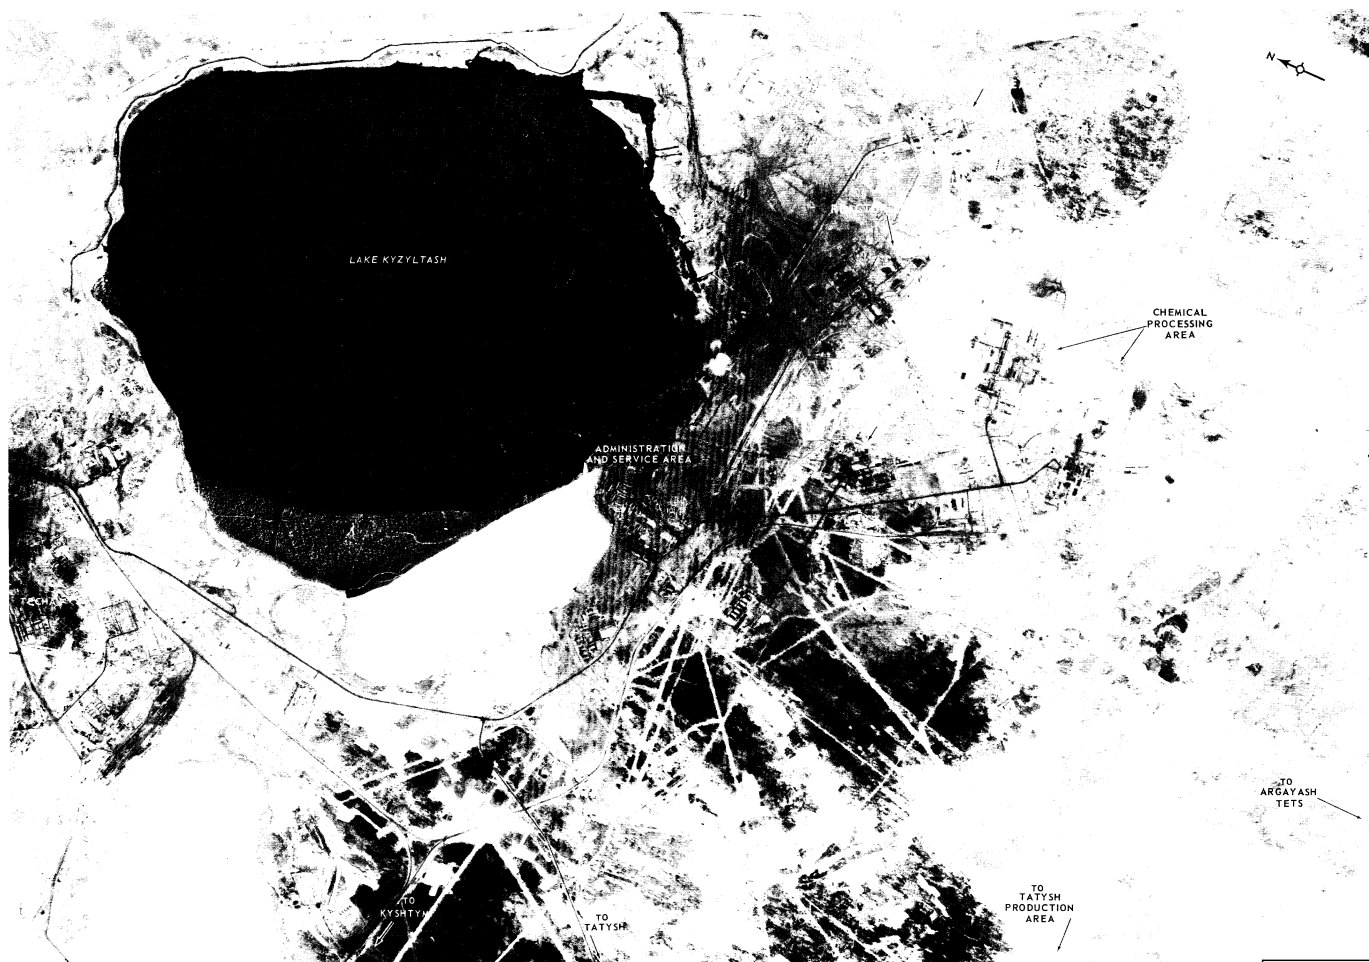
FIGURE 1. KYSHTYM ATOMIC ENERGY COMPLEX.

This report updates [ ] information on the Kyshtym Atomic Energy Complex 1/ and is based on all previous [ ] photography of the complex and on excellent [ ] photography of [ ] (Figures 1 and 2). The [ ] photography in particular permitted an extensive refinement of building details and configuration and a detailed reevaluation of electric power circuitry. Except where noted, changes and new identifications described in this report were made possible by the improved quality of the [ ] [ ] photography rather than by actual changes on the ground. At that time the complex was covered by light snow which had drifted in some parts of the complex; the snow was heavier over the eastern portion of the complex and quite light in the vicinity of the Administration and Service Area. Measurements based on the [ ] photography cannot be included in this report because of mensuration problems which are currently being resolved.

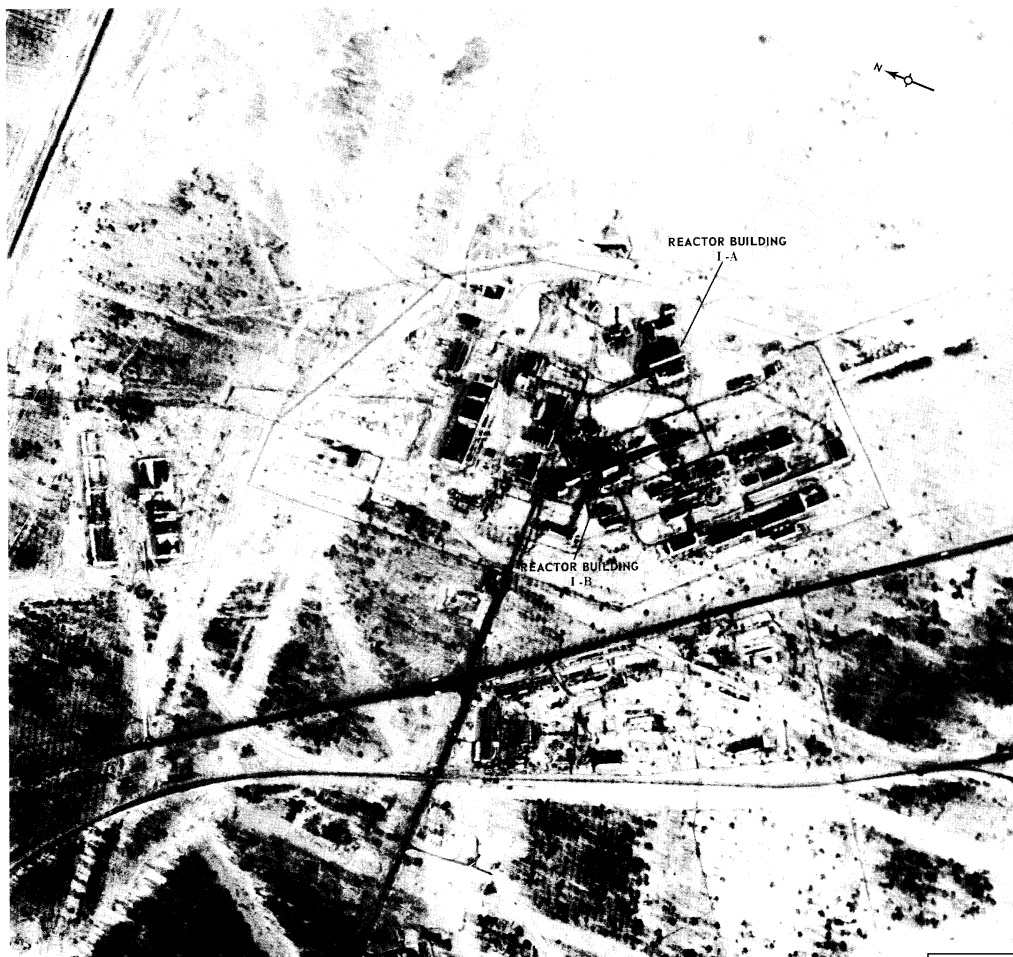
FIGURE 3. REACTOR AREA I

A newly identified inner wire fence parallels the existing solid fence which surrounds Reactor Area I (Figures 3 and 4). The solid fence is probably a wire fence interlaced with boards or a board fence. Guard towers are situated in at least four corners of the area. The existence of one of the previously reported possible rail spurs serving the southern portion of the area has been confirmed, and two newly observed rail spurs serve the cross-shaped building connected to Reactor Building I-B. Building numbers are keyed to Figure 4.

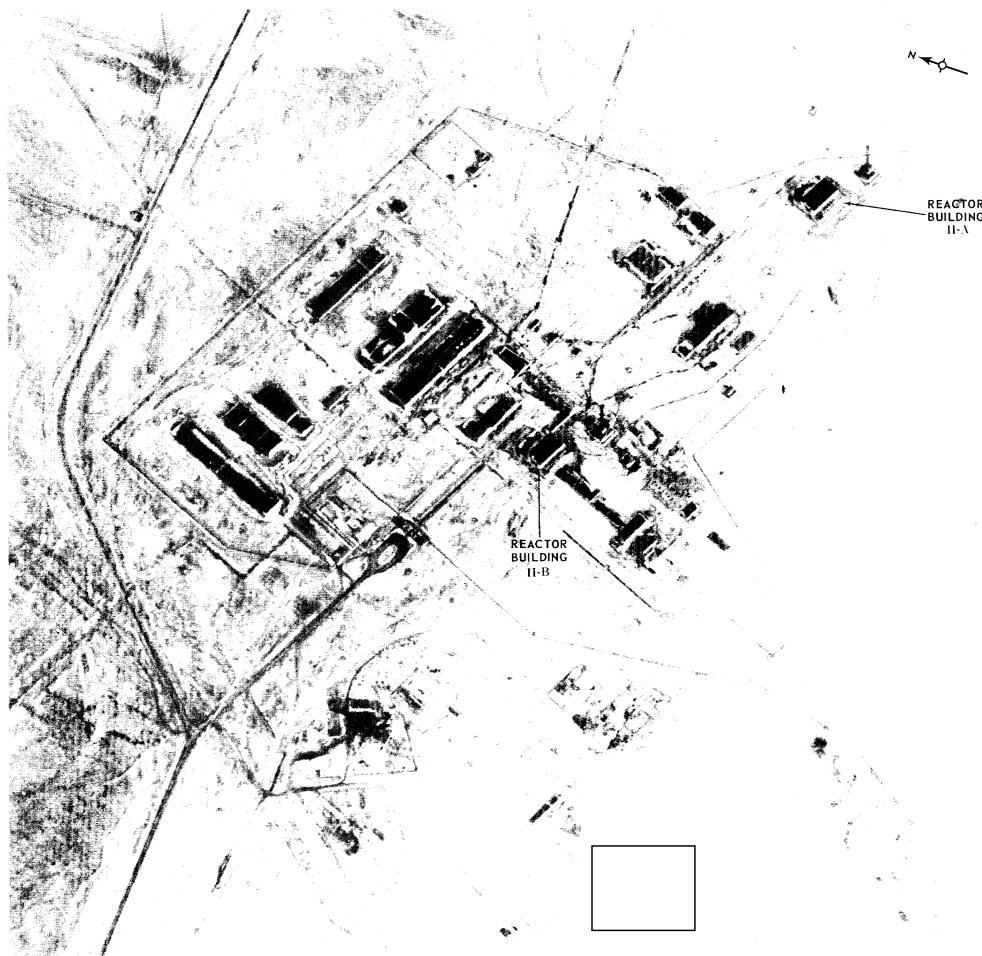
FIGURE 5. REACTOR AREA II

laced with boards or a board fence), Reactor Area II is now enclosed by a newly identified inner wire fence (Figures 5 and 6). The area is divided into two sections by a probable wall which extends from a guardhouse at the main entrance to a possible pumphouse at the eastern perimeter fence. Security precautions for the southern half of the area now include two guardhouses at the main entrance to the area and at least three guard towers; a new L-shaped guardhouse for the northern half of the area is located west of the T-shaped administration building just outside the main entrance to the reactor area.

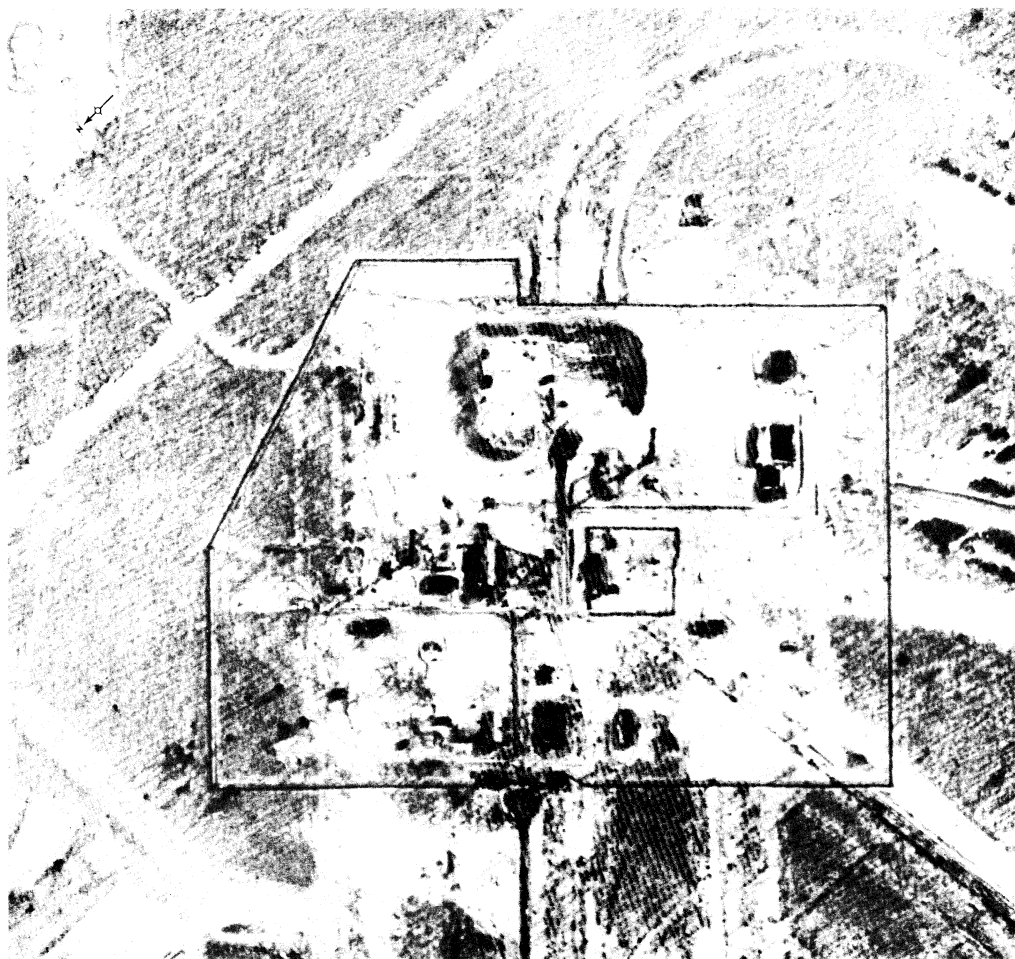
FIGURE 7. REACTOR AREA III.

Although the photography of Reactor Area III is excellent, it does not provide sufficient evidence to determine the operational status of the area (Figures 7-9). The road turnaround just outside the main entrance has been cleared of snow and showed signs of heavy traffic. However, the main gate was closed, and snow had drifted against it. Some stretches of road inside the area were not snow covered, but whether the snow had been removed by plows or by wind could not be positively determined

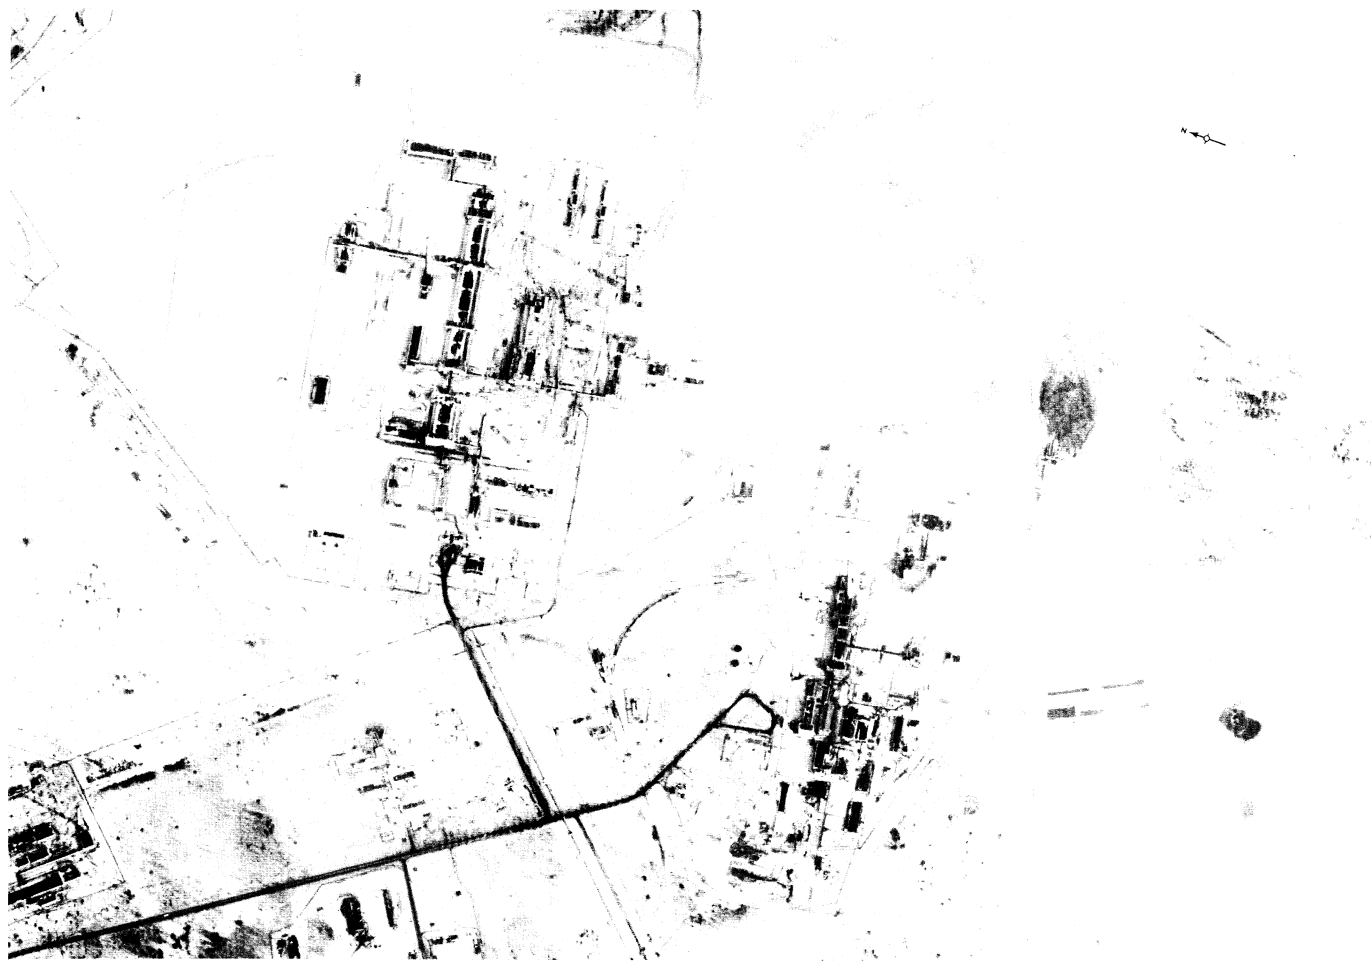
FIGURE 10. CHEMICAL PROCESSING AREA,

Two security fences similar to those observed at the three reactor areas not only surround most of the Chemical Processing Area but also separately secure the southern portion of the area (Figures 10 and 11). In addition to the three previously reported chemical separation plants, 1/ a fourth chemical separation plant has been identified in the southern portion of the area. Whether or not there is a tritium plant in the southern half of the area cannot be determined from the photography at this time. Building numbers are keyed to Figure 11 and Table 2.

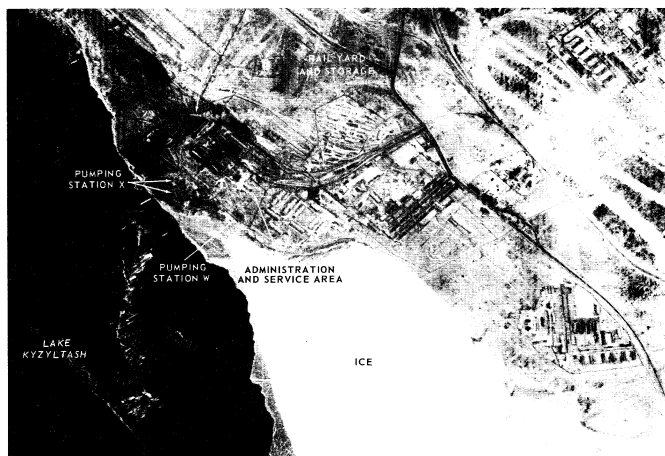
FIGURE 14. ADMINISTRATION AND SERVICE AREA.

In addition to the water treatment plants in and near Reactor Areas I and II, the separately secured eastern portion of the Administration and Service Area on the southern shore of Lake Kyzyltash also contains water treatment facilities (Figures 14 and 15 and Table 3). These include two water treatment plants (items 1 and 9), a water treatment building (item 10), and Pumping Stations W and X (items 12 and 14). A steamplant (item 2) with an associated coal thawing building (item 3) and substation A are also situated in the immediate vicinity of these facilities. Previously considered as a main administration building, 1/ the largest water treatment plant (item 9) in the area is a T-shaped structure with a one-story stem and a crossbar having a narrow second story. A high tower is situated in the middle of this plant, and a small tower, two or three stories high, is located at the west end of the crossbar. The configuration of this plant differs from the configurations of the water treatment buildings observed in and near Reactor Areas I and II. A long low water treatment building (item 10) is located south of the T-shaped plant, and a head structure at the east end of the building is probably three
